U.S. ENVIRONMENTAL PROTECTION AGENCY - REGION 6
FINDINGS OF VIOLATION, COMPLIANCE ORDER, AND INFORMATION DEMAND
In the Matter of Creed Operating Company, LLC (Respondent)
Docket No. CWA-06-2013-1724

INSPECTION REPORT

Creed Operating Facility Co., LLC

Subject: Novice Unit Lease RRC 10904 Discharges to tributary and Jim Ned Creek (Point of Entries)

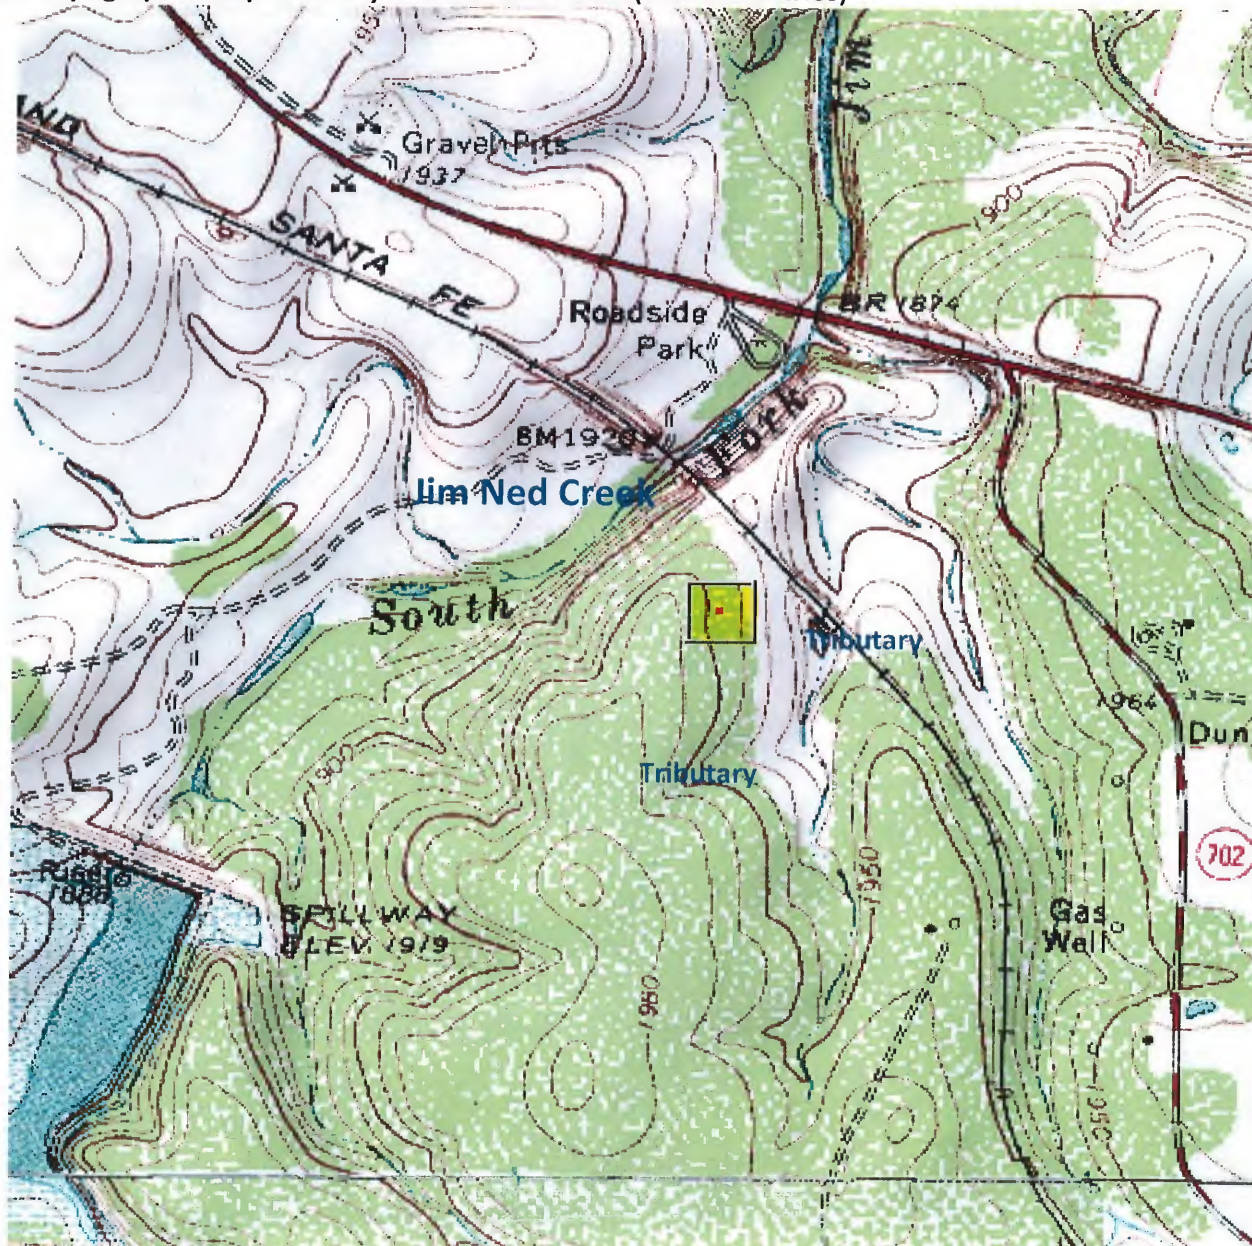
Subject: Topographic Map tributary and Jim Ned Creek (Point of Entries)

Topographic Map of Creed facility showing tributaries and Jim Ned Creek. Unnamed tributaries run North towards Jim Ned Creek.
